# **SPECIAL AIRWORTHINESS INFORMATION BULLETIN**

No. CE-03-48  
August 8, 2003

This Special Airworthiness Information Bulletin (SAIB) alerts you, an owner or operator of the **SCHEMPP-HIRTH Model Duo Discus T gliders (serial numbers 1 through 78)**, that Luftfahrt-Bundesamt (LBA) has issued an Airworthiness Directive (AD) 2003-245/2, dated August 1, 2003. The LBA AD and SCHEMPP-HIRTH technical notes require an immediate inspection of the upper spar cap and the spar web before further flight.

<b>SCHEMPP-HIRTH</b> <b>Flugzeugbau GmbH.</b> <b>Kirchheim/Teck</b>	<b>Appendix to</b> <b>Technical Note</b> <b>No. 396 – 8 / No. 890 - 3</b>	Page No: 01 No of pages: 10
---	---	--------------------------------

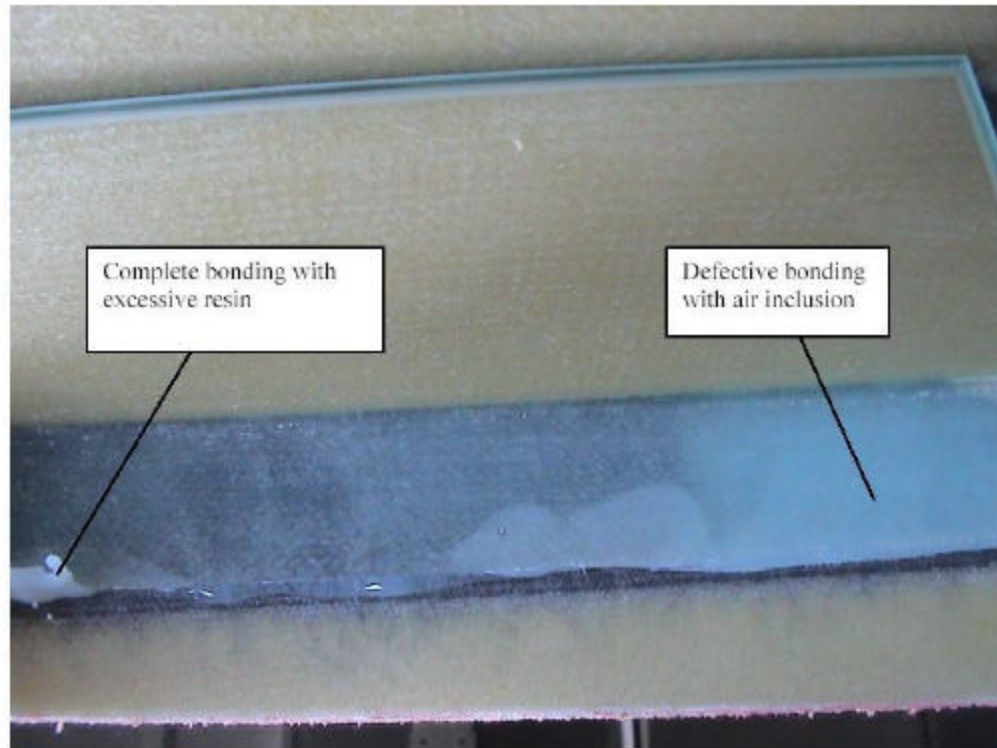
A showcase photo on page 8 indicates the following in the area of the break:

- a complete bonding with excessive bonding resin
- a defective bonding –white area (air inclusion)
